Dust Collector Fire and Explosion Highlights Need for Combustible Dust Considerations In System Designs

A massive fire and explosion in the dust collection system of a New Hampshire wood pellet manufacturer demonstrates the need for adequate system design to prevent combustible dust explosions in general industry.

May 16 2012 – Baghouse.com Editorial | We recently published a [news article](#) on Environmental-Expert.com about OSHA's enforcement actions concerning last year's combustible dust fire and explosion at the New England Wood Pellet Company's Jaffrey, New Hampshire wood pellet plant.

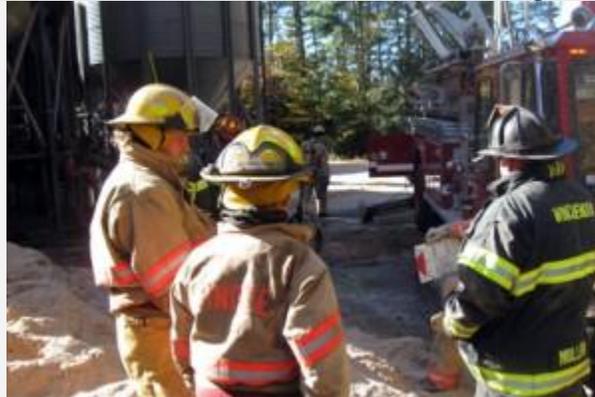
Fire fighters work to put out a massive blaze caused by a destructive combustible dust fire and explosion at the New England Wood Pellet Company's Jaffrey, NH facility.
